Salvage vertebral arteriotomy for micro guidewire retrieval in a patient with basilar artery stenosis, a rare case report

Abstract

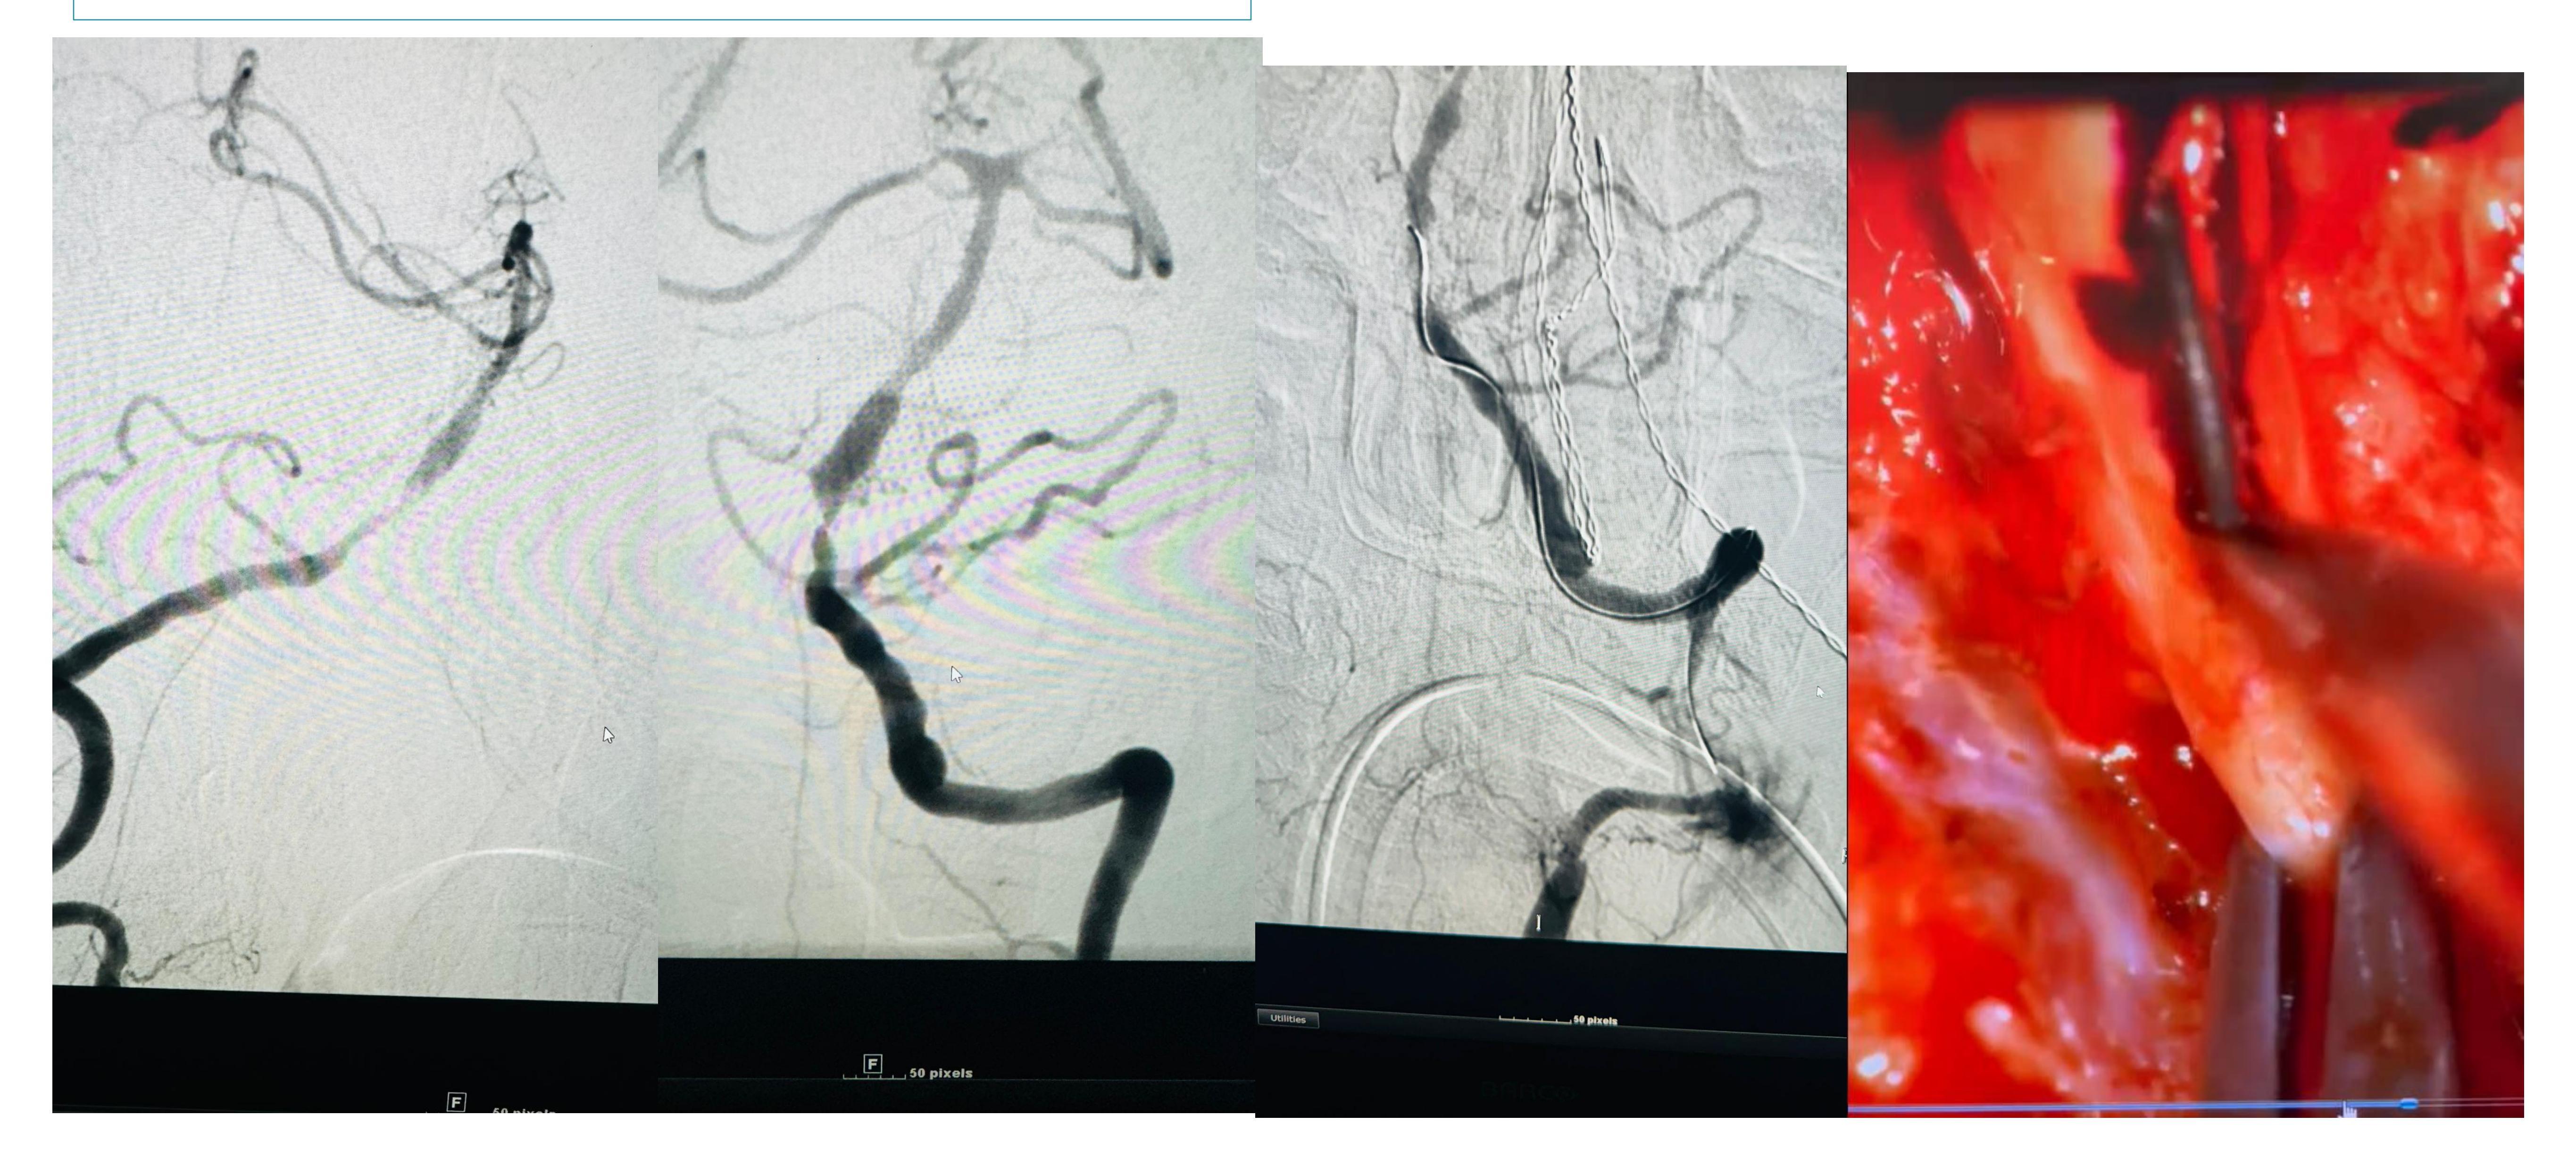
Figure 1. preintervention oblique view angiogram showing basilar stenosis.

Figure 2. AP angiogram image in the stenosis.

Figure 3. vessel perforation and GW fracture. Please notice the dye extravasation.

Figure 4. vertebral arteriotomy and GW retrieval.

A 59-year-old female with a history of vertebrobasilar insufficiency was referred for basilar artery (BA) stenting (Figure 1). After the Synchro® (Stryker Neurovascular[™], California, USA) wire navigation through the atherosclerotic stenosis, GW fracture occurred and distal segment remained in the V3-BA lumen(Figure 2). Multiple attempts, including Microsnare® application remained unsuccessful. There was V2-V3 extravasation. The patient received a heparin drip for 24 hours and was scheduled for far lateral craniotomy.

Using a classic far lateral approach, we gained access to the V3-BA segment of the vertebral artery, and a small arteriotomy on the V3 was performed (Figure 3). GW was retrieved and the patient was discharged for future re-stenting. There were no new post-operative events in the follow-up period.
